Safety Bulletin

Date: December 2016 **Domestic Gas Regulator Safety**

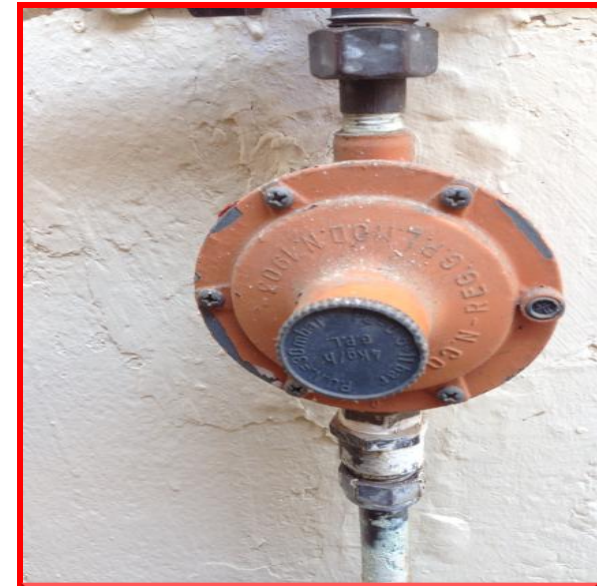
On 10th November 2016, a faulty domestic gas regulator was connected to a new gas cylinder in one of RAH houses. The regulator failed to control gas flow resulting in high pressure gas supplied to the oven causing a small explosion. Luckily no injuries.

Defected Regulator

- Always ensure domestic gas regulator are inspected regularly by approved competent person.
- Always replace worn-out or defective tubing and regulators with genuine parts.
- Check for gas leaks regularly by applying soap solution on cylinder joints and other fittings.
