Safety Alert

Rigger crushed during an unloading operation!

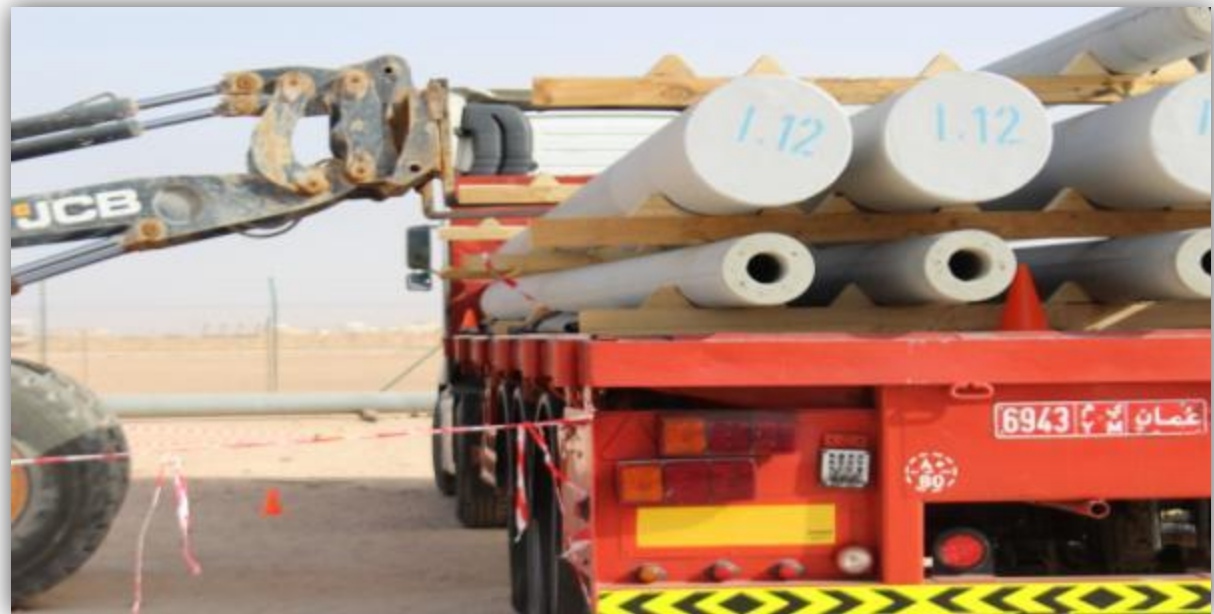
Lifting Equipment

- Tool carrier used instead of a crane
- Incorrect equipment used for the operation
- Lack of planning & supervision
- Rigger position in the line of fire

- Ensure the lifting equipment is suitable for lift operation and shall meet PDO procedure PR-1708 & SP-2273 requirements
- Ensure all lifting equipment are certified and the lifting crew are competent
- Ensure the lift plan is in place and make sure TBT is conducted

- Always follow the right procedure for tubular (pipes & poles) handling.
