LTI 04: Crushed Finger

3-Feb

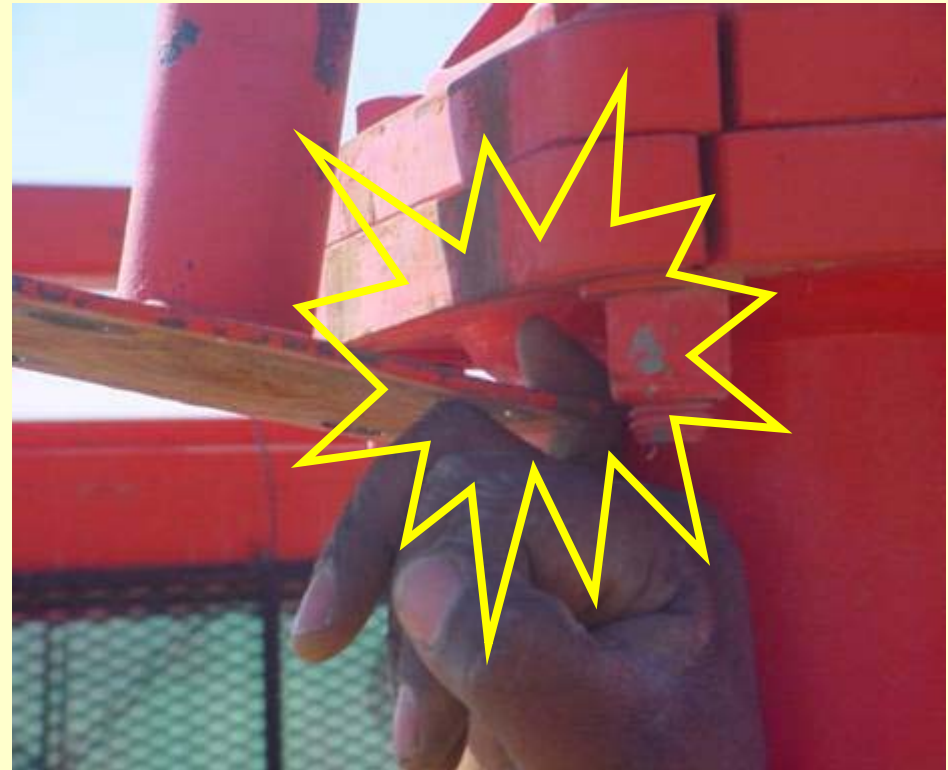
A "U" shaped bar was being removed from a vibrator. One side had been unbolted and was loose; the other was jammed. A Hiab crane hook was attached to the bar on the stuck end. During lifting, the hook slid down the bar and raised the free end, trapping employee's finger between the base of the bar being removed and the cross-member.

- Crushed finger
- 15 days lost work

- Inadequate Supervision
- Improper use of Hiab
- Could this be avoided?
