Injury while Nippling Up Koomey Bottle

INCIDENT

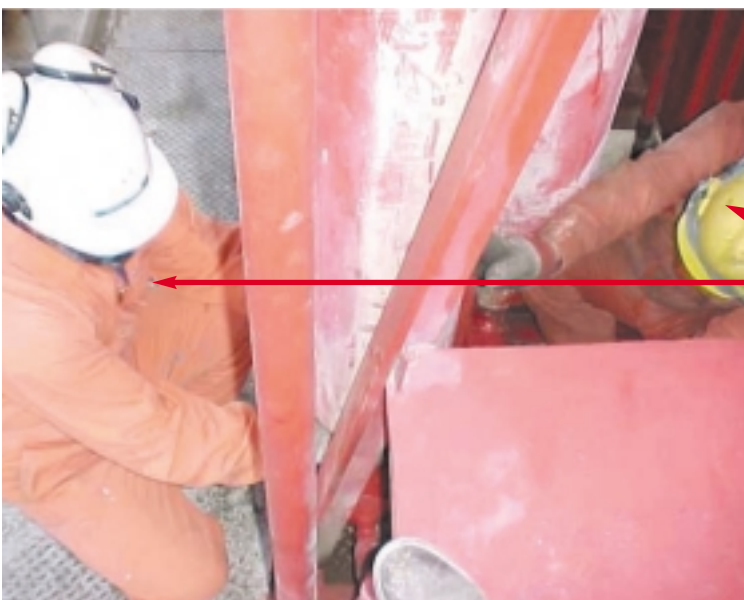
The job of nipping up koomey accumulator bottles to the manifold was in progress by using a webbing sling and the crane to lift each bottle. While ligning one bottle to the nipple of the manifold, the bottle dislodged from the nipple , came out from the U-clamp and fell down through the flooring. One floorman , who was holding the bottle for screwing into the nipple, received crush injury to his right hand.

These two persons were injured while nipping up Koomey bottle that was unsecured.

- Correct Manual Handling is essential to prevent accident.
- Shortcuts must NOT be attempted.
