Third Party Fatality RTA at Mukhaizna

The Incident:

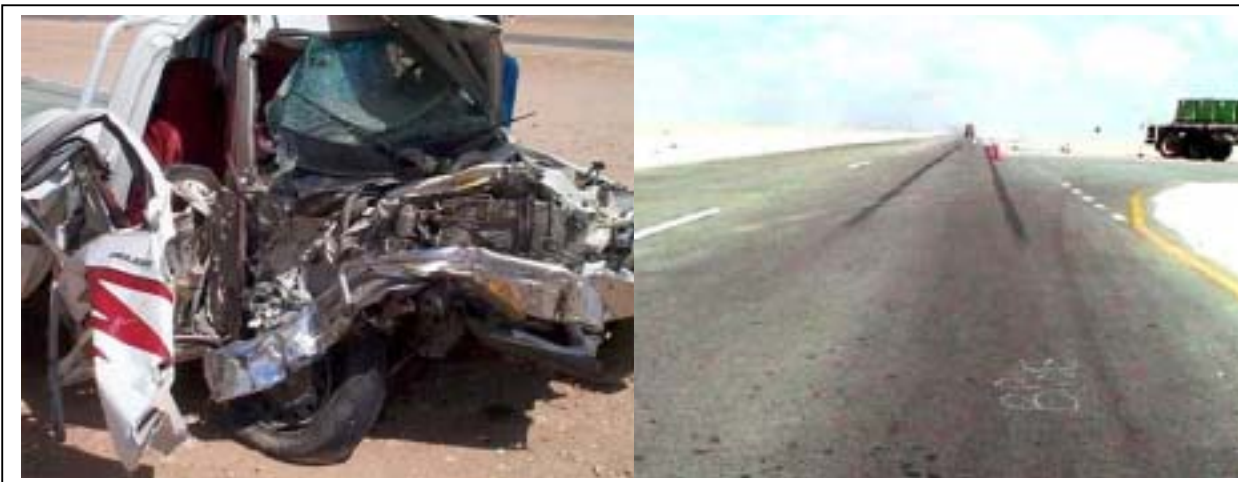
A sub-contractor prime mover and trailer combination travelling at night was turning left across the Haima-Rima road to enter the Mukhaizna lay-by area. A third party pick-up, travelling in the opposite direction (Rima-Haima), crashed into the trailer. The driver of the pick-up was killed, and the passenger, severely injured. The driver of the prime mover and trailer combination was uninjured.

- Misjudgement of oncoming traffic - poor eyesight/ night vision by prime mover driver
- Night driving without approval, and non-assessment of possible risks
- Non-compliance with Journey Management Procedures – deficient Safe Journey Management Plan, night stop not observed, no arrangements for communication between Journey Manager and driver, etc.
- Third party driver not following traffic rules – driving at excessive speed (160 – 170 kph)
- Third party driver distracted by searching for dropped article on pickup floor (GSM?)
- Ineffective management of sub-contracted activities.

- Strictly adhere to driving rules (SP-2000), including “No Night Driving” policy
- Where night driving permission is required, carefully examine all possible risks – total driving hours, driver’s medical condition/record, road condition, communication/GSM coverage, load on the truck, etc.
- Safe Journey Managers (SJM) must clearly understand their responsibilities and strictly enforce the requirements of Safe Journey Management Plan. **Only SJM who have been assessed competent are allowed to perform this role.**
- Ensure adequate medical examination for all drivers in accordance with SP 1230.
- Ensure adequate controls are in place to manage sub-contracted activities; sub-contractor audits must focus on high risk areas or activities.
