Sub : Falling object injury – Newspaper report

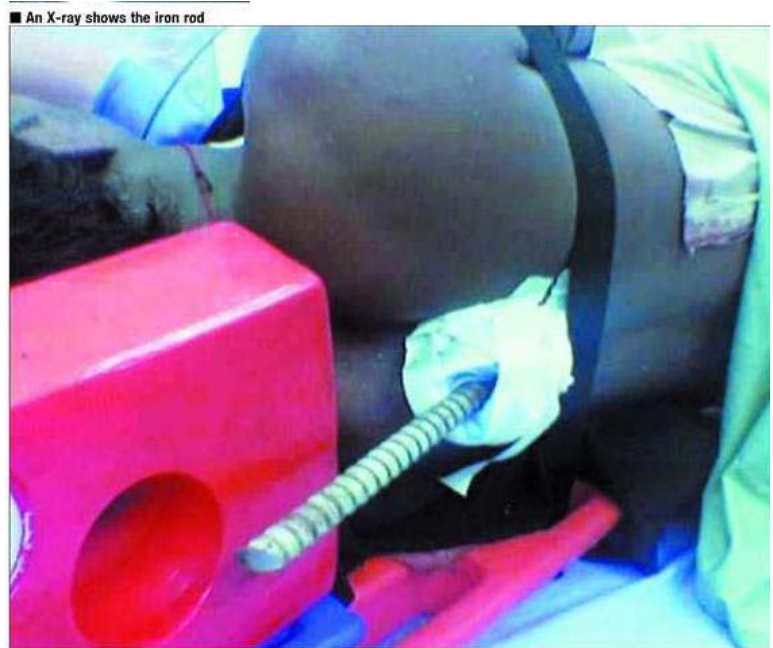
This accident has been reported in one of the newspapers. The worker was standing at the bottom of a tower under construction in Dubai when an iron rod, 2.5 metres long and 18 centimetres thick, fell vertically from the 25th floor of the building. **The bar penetrated his back and came out through his pelvis.** The worker was airlifted from the site to the hospital, where he was immediately given antibiotics and painkillers.

The workers life was saved because the rod was left in his body until he arrived in the hospital.

■ The worker's life was saved because the rod was left in until he reached hospital All photos ET FILE

- Maintain good house keeping in the workplace
- Contain all loose materials in appropriate containers.
- Secure objects that can be dislodged by wind
- Dispose off scraps on completion of work

- Cover all unattended openings with a material that can withstand twice the intended load and ensure that it cannot be displaced from its location.
- Ensure provision of edge protection in floors, shafts, scaffoldings, suspended access etc., and monitor the same at regular intervals.

- Screen the gaps between the handrails and toe boards, appropriately, to avoid fall of materials through the same
- Ensure overhead protection if parallel work is undertaken overhead

- Hand tools used at higher elevations, particularly near the periphery of buildings, shall be secured to avoid their fall due to slippage
- Ensure proper rigging of materials before lifting the same. Barricade the lifting area to avoid unauthorized personnel. Avoid traveling load over personnel.

- Report all nearmiss cases to the concerned, for action
- Last but not the least, for such penetration injuries do not attempt to remove any such penetrated object as it may be detrimental to the victim. Call emergency services to arrange immediate medical attention.
