SAFETY ALERT #362

Dated: Sunday, 1st NOVEMBER 2009

Title: SCAFFOLDING INJURY

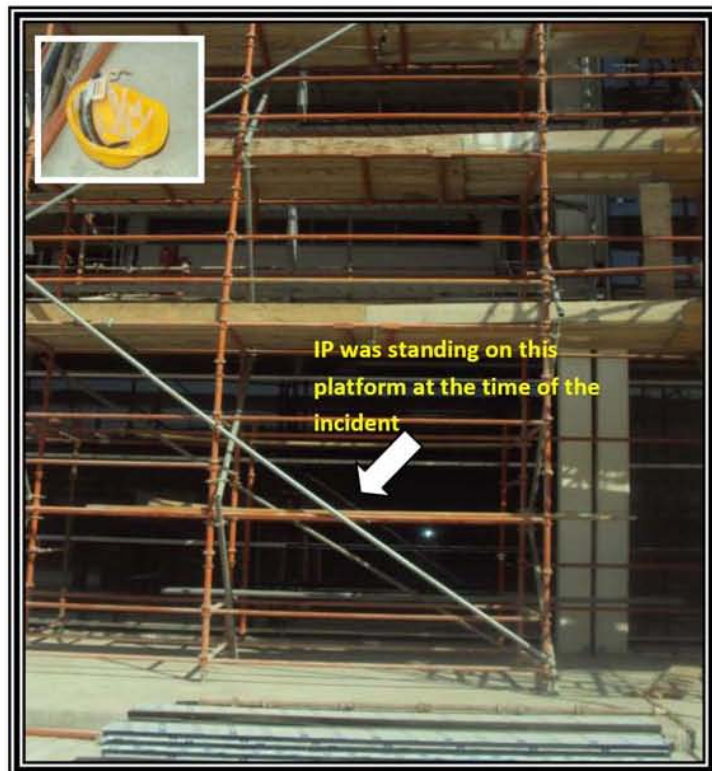
This **HARDHAT** saved
my life!...

A subcontract scaffolder on site was taken to the hospital after suffering a small cut which required 6 stitches to his head. A team of scaffolders were engaged on dismantling of scaffolding erected along perimeter of the building. They were using "HANDBALL" method where the components are dismantled from the top and passed downwards to ground using a chain of people. The IP was a part of the team approximately 2 meters above the ground of level 00. The other scaffolder at level 4 passed the standard down to his colleague at level 3 but he failed to grasp the standard properly letting it slip through his hands down to the scaffold lift level. The impact knocked the scaffolder to the ground sustaining injury to his head. He was wearing his helmet. The emergency response team was contacted and the emergency vehicle attended the site. The injured person was transported to the hospital for further treatment, medication and examination.

- Tool Box given to all operatives regarding manual handling the brief preview incident happened and manual handling
- Incident investigations have been undertaken by our HSE team
- Immediate medical attention given to the injured person

The hazard for consideration is falling objects where the task being undertaken is erecting or dismantling of scaffolding using the labour intensive "HANDBALL" method. The ground crew must access and work in such a way as to ensure that they are protected at all times overhead by the above deck or other means. The risks are elevated when the scaffolding deck is high with multiple manual handlings of the equipment. All work zone to be barricaded and signed where there is a risk of falling object. The hierarchy of risk should be applied and elimination of the task should be considered.

This method of handballing has been the result of numerous accidents in Dubai. An alternative method should be devised to eliminate this hazard. If resorting to this method, persons should be staggered & not directly above or below each other. Competent supervision to ensure safe work procedures are followed. Ensure exclusion zone around the exercise - there should be nothing below the lifting zone. Fatigue kicks in with all manual handling, so more rest periods would be appropriate. Mechanical means to be used wherever possible, manual handling to be considered as a last resort.
