PDO Contractor Health, Safety and Environment Notice

MOBILE CRANE OPERATIONS

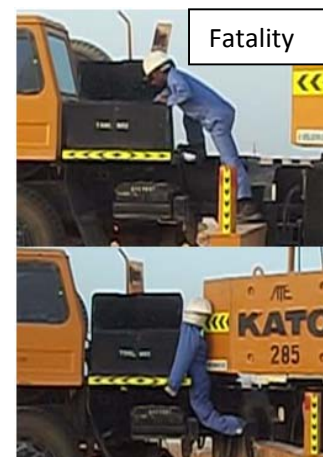
PDO recently suffered a tragic incident where a helper was fatally crushed by the rotating counterweight of a mobile crane. He used the outrigger as a step to climb up onto the bed of the crane to retrieve slings from the toolbox which had been fitted by the original equipment manufacturer (OEM).

As part of the PDO HSE MS requirement for continual improvement all PDO contractors involved using mobile cranes are required to immediately conduct a risk assessment of their fleet of cranes in relation to their operational hazards and identification and removal of any similar crush points.

Urgent remedial action to prevent a recurrence of this incident is also required to include locking/removal/redesign or relocation of the toolboxes/wheels. **Modification requires approval of OEM.**

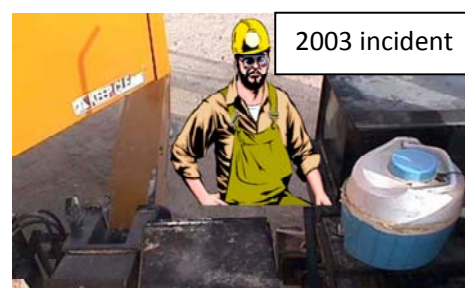
The team also identified alternative crush points on other mobile cranes including the inappropriate placement of spare wheels.
